X30 & KA100 Coil Earth Connection

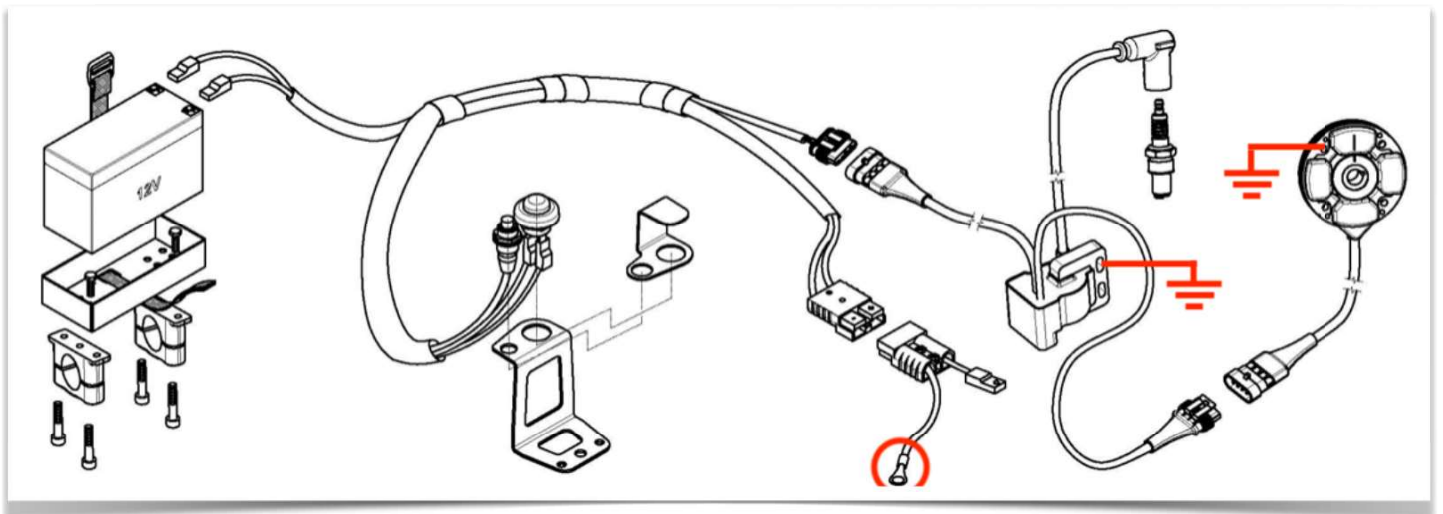
On rare occasions we have seen coils from customers that have burnt out seemingly with no explanation, recently we learned the cause for this failure is the result of an unsteady connection between the negative (-) pole of the battery and the starter motor body. The unsteady connection is generally between the ground eyelet and the starter motor or within the big red connector.

When the Start button is pushed the large current (80A approx.) feeding the starter motor passes from the battery to the button, then to the terminal in the red connector, then to the starter motor wire for the "+", through the starter motor body then to the eyelet (circled in red) and the crankcase (ground).

If the ground connection "-" is weak, the 80A current cannot pass fully through the eyelet from the starter motor, so the current looks for an alternative path. In the case it finds its way to the coil the circuit board inside cannot tolerate such high current so a component burns out immediately when the Start button is pushed.

To avoid this situation check that the eyelet (circled in red) is firmly fixed directly under one of the screws mounting the starter motor contacting the metal case. Also check the terminals inside the red connector are clean and all crimps/connections are making firm contact, this check should be performed regularly as routine maintenance. As this type of failure is not a fault of the coil it is not something that can be claimed as a warranty issue.
